**Flood Control Project Maintenance
Levee Inspections**

Maintenance Issue Types Only, Levee Inspection Report By Mile - Fall 2014

Reclamation District No. 2058 Pescadero

Waterway	Bank	Unit Miles	Inspection Start/End	Inspector
Unit No. 01 Paradise Cut	Left	6.58	11/12/2014 11/12/2014	Maksim Khashchuk

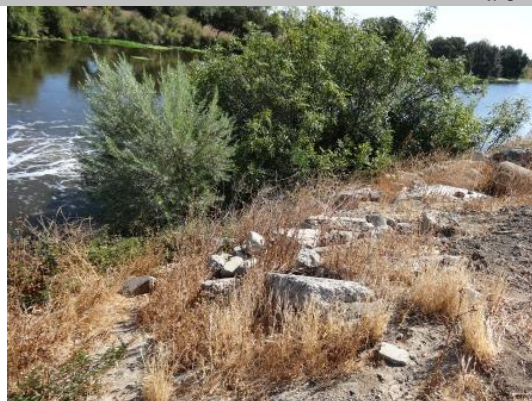
Photo 1 of 1 : SJR2014_RD2058U01RM1.78_1.jpg

LM Start	2.15	Rating **	M	Issue No.	1
LM End	2.15	Issue Type +	Ma	Location *	WS
Category	Supplemental			GPS Latitude/Longitude	
				Start	End
Item	DWR Erosion Survey			37.803769 °	37.803769 °
				-121.386341 °	-121.386341 °
DWR ID

Inspector Comments: 08/26/2014: No significant change observed.
08/28/2013: No significant change observed.
07/31/2012: Site was visited on 07/26/2012. No significant change observed. A new vertical pipe was installed and concrete blocks left on the site. Dense vegetation is visible at the site. No signs of new leaks or spill from the siphon breaker.
09/02/2011: Site was not visited due to the time limit.
09/22/2010: No significant change observed. Vegetation downstream, upstream and on the lower slope of the site have been recently sprayed. These areas were also fenced off during the site visit, making it difficult for us to examine the condition of the lower slope. Possible leak or spill from the siphon breaker is creating notches along the slope and developing into a headward erosion. If the problem continues, it will erode the slope and fully expose the pipe to outside elements.
07/23/2009: A possible leak or spill from a siphon breaker is eroding the slope and developing into a headward erosion; a portion of the buried pipe is exposed; the lower slope seems to be lined with chunks of concrete debris or other rock material. [2014 Site ID:RD2058U01RM1.78]

Direct view of the site.

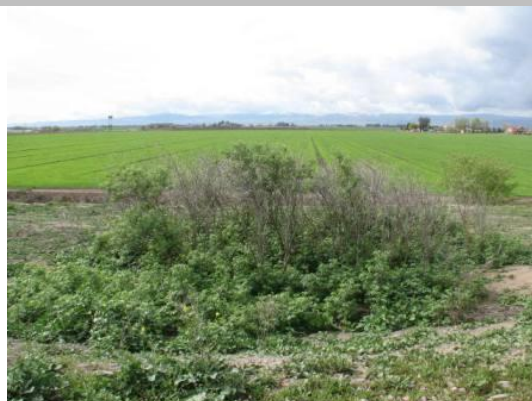
Photo 1 of 1 : FA_2014_RD2058_111_16_20141001_00007.jpg

LM Start	2.42	Rating **	A/W	Issue No.	16
LM End	2.42	Issue Type +	Ma	Location *	LS
Category	Earthen Levee			GPS Latitude/Longitude	
				Start	End
Item	Vegetation			37.802782 °	37.802782 °
				-121.381413 °	-121.381413 °
DWR ID	DWR RD2058 01 s 2012 16

Elderberries are blocking visibility and flood fight capability.
Inspector Comments: Elderberry growing on landside toe.

03/28/2012 Large elderberry bush on landside slope.

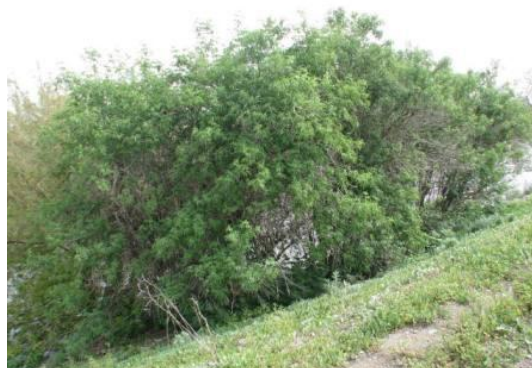
Photo 1 of 1 : FA_2014_RD2058_111_63_20141001_00018.jpg

LM Start	2.64	Rating **	A/W	Issue No.	63
LM End	2.64	Issue Type +	Ma	Location *	WS
Category	Earthen Levee			GPS Latitude/Longitude	
				Start	End
Item	Vegetation			37.801962 °	37.801962 °
				-121.377684 °	-121.377684 °
DWR ID	DWR_RD2058_01_s _ 2012_63				
Action/Comments					
Elderberries are blocking visibility and flood fight capability. Inspector Comments: Elderberry on waterside slope.

03/28/2012 Large elderberry bush located on waterward slope.

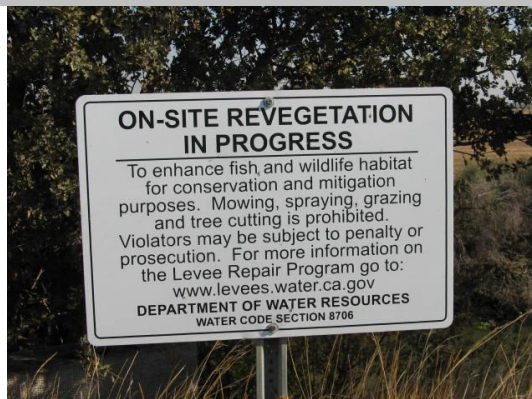
Photo 1 of 1 : FA_2014_RD2058_111_20_20141001_00008.jpg

LM Start	3.85	Rating **	A/W	Issue No.	20
LM End	3.85	Issue Type +	Ma	Location *	WS
Category	Earthen Levee			GPS Latitude/Longitude	
				Start	End
Item	Vegetation			37.790807 °	37.790807 °
				-121.362905 °	-121.362905 °
DWR ID	DWR_RD2058_01_s _ 2012_20				
Action/Comments					
Environmental Requirements.					
Inspector Comments: Revegetation site.

11/08/2011 Revegetation site, cannot trim or cut vegetation in this area.

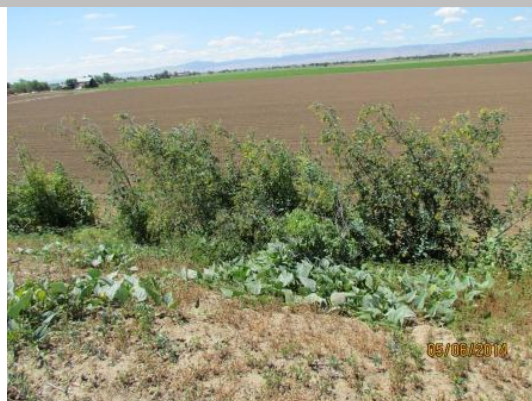
Photo 1 of 1 : FA_2014_RD2058_111_22_20141001_00009.jpg

View of the tall vegetation on the landside levee slope and toe.

LM Start	3.96	Rating **	M	Issue No.	22
LM End	3.96	Issue Type +	Ma	Location *	LS
Category	Earthen Levee			GPS Latitude/Longitude	
				Start	End
Item	Vegetation			37.789434 °	37.789434 °
				-121.361721 °	-121.361721 °
DWR ID	DWR_RD2058_01_s _ 2014_22				
Action/Comments					
Remove the wild growth other than native grasses from the levee slopes.

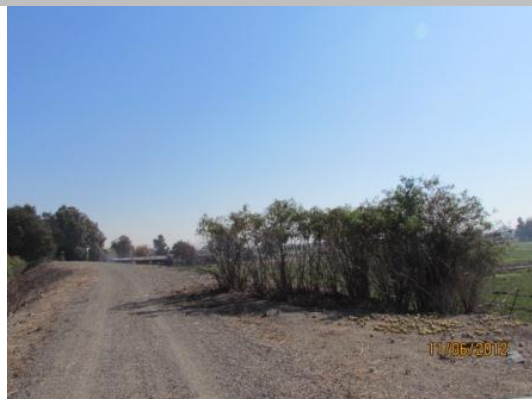
Photo 1 of 1 : FA_2014_RD2058_111_26_20141001_00011.jpg

LM Start	4.01	Rating **	M	Issue No.	26
LM End	4.01	Issue Type +	Ma	Location *	LS
Category	Earthen Levee			GPS Latitude/Longitude	
				Start	End
Item	Vegetation			37.789128 °	37.789128 °
				-121.361042 °	-121.361042 °
DWR ID	DWR_RD2058_01_s _ 2012_26				
Action/Comments					
Elderberries are blocking visibility and flood fight capability. Inspector Comments: Elderberry on landside hinge point.

Elderberry bushes on landside slope.

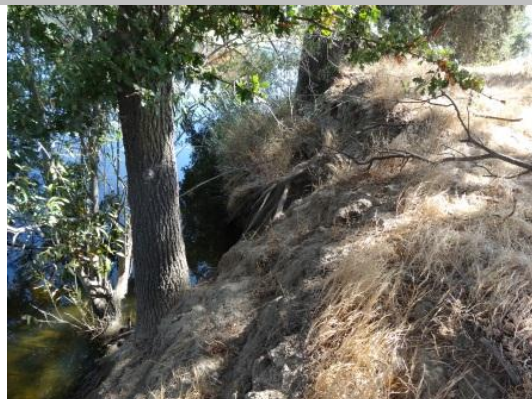
Photo 1 of 1 : SJR2014_RD2058U01RM3.97_1.jpg

LM Start	4.49	Rating **	M	Issue No.	2
LM End	4.53	Issue Type +	Ma	Location *	WS
Category	Supplemental			GPS Latitude/Longitude	
				Start	End
Item	DWR Erosion Survey			37.789810 °	37.789810 °
				-121.352490 °	-121.352490 °
DWR ID					
Action/Comments					
Inspector Comments: 08/26/2014: No significant change observed. 08/28/2013: No significant change observed. 07/26/2012: The site has been visited, and no significant change has been observed. 09/02/2011: This site was not visited due to the time limit. 09/22/2010: No significant change observed. Minor pocket erosions are lined at the lower bank. Two large Oak and Willow trees are on mid-slope and bench. The remaining bench was re-measured and found to be approximately 10 feet. There was no indication of active erosion on site during the site visit. 08/05/2010: Recommended for annual assessment and monitoring of the site during flood events, per CLRO. 07/23/2009: No major change observed since last visit; site is a 200-ft. long near-vertical berm erosion; recommend annual assessment and monitoring of the erosion site, per CLRO CES Evaluation 2008 Report; Site # is the same site previously reported as RM4.0,LM4.51; previously rated "U". 09/10/2008: Two large trees (2-3' DBH) with partial roots exposed. 2007: Visited site 03/13/2007. [2014 Site ID:RD2058U01RM3.97]

Direct view of the erosion near a tree.

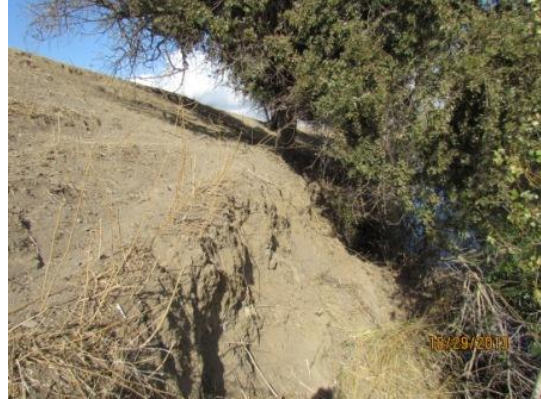
Photo 1 of 1 : FA_2014_RD2058_111_15_20141001_00006.jpg

LM Start	4.82	Rating **	U	Issue No.	15
LM End	4.82	Issue Type +	Ma	Location *	WS
Category	Earthen Levee			GPS Latitude/Longitude	
				Start	End
Item	Erosion / Bank Caving			37.785862 °	37.785862 °
				-121.350303 °	-121.350303 °
DWR ID	DWR_RD2058_01_f_2013_15				
Action/Comments					
Note and monitor erosion site. Inspector Comments: The erosion has about a 3 foot vertical cut at the waterside levee toe.

View of the erosion at the waterside levee toe.
